NASA  
Technical Memorandum 86881

# Experimental and Analytical Study of Ceramic-Coated Turbine-Tip Shroud Seals for Small Turbine Engines

January 1985

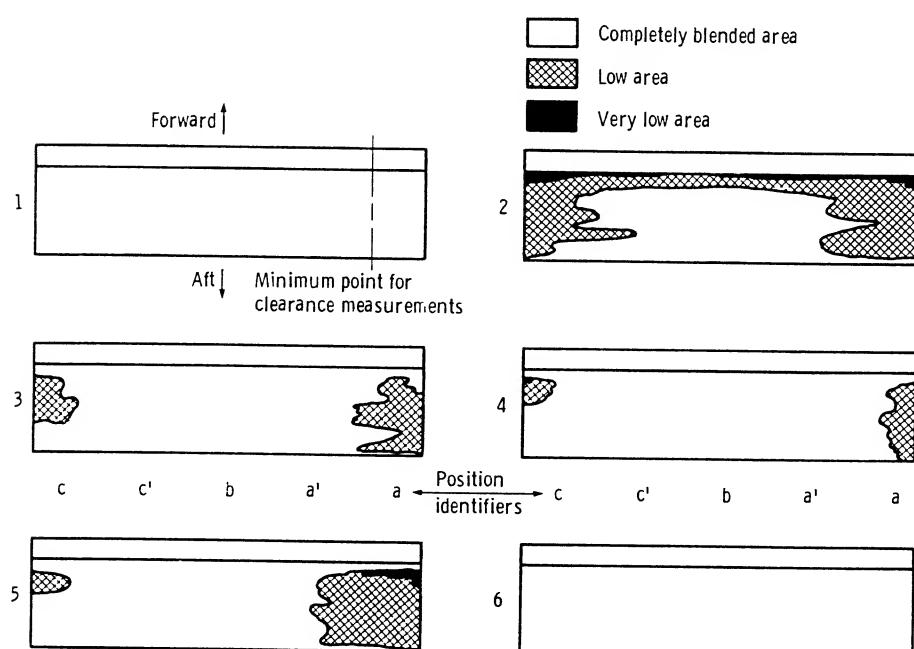
Figure 6. - Schematic of ceramic shroud thicknesses as installed in engine after final grinding.

- (f) A shiny area on the metal leading edge of shroud 1. The area was about 19.1 mm (3/4 in) long and extended into half the metal width between position indicators a and b. (See fig. 6.)
- (g) All other shrouds looked OK; additional sign of use was visible as overall darkening.

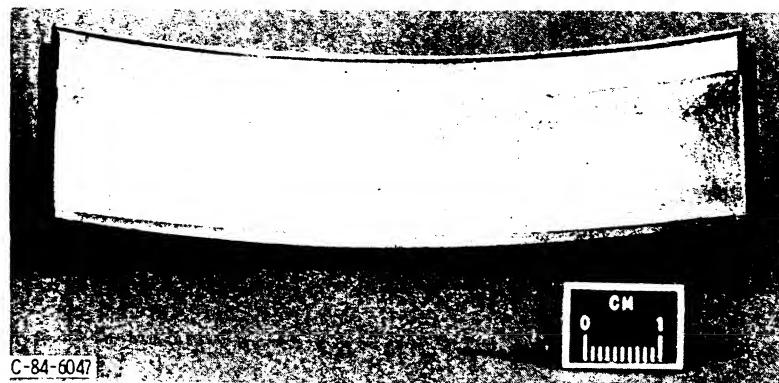
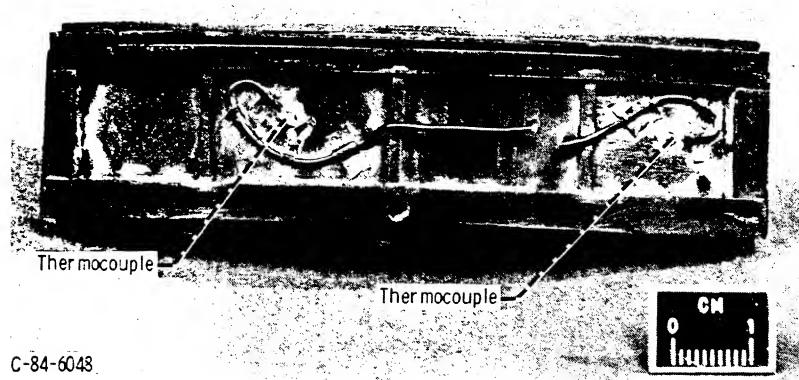
A photograph of the shrouds before installation in the engine is shown in figure 3. Photographs of a shroud after removal from the engine are shown in figure 12. Visual inspection reports after 4, 210, and 739 cycles are contained in appendix B. Comments on the condition of the shrouds after completion of testing are contained in ANALYSIS OF A MATERIALS SECTION, which is to follow.

In this evaluation, one shroud (shroud 6) and a typical cross section were metallographically examined. The front and back surfaces of a typical shroud are shown in figure 12, which indicates a reasonably smooth surface without visible defects. Some slight erosion was evident, along with a small amount of 8-wt % yttria-stabilized zirconia ceramic darkening. Macroscopic observations (figs. 17 and 18) (at 32x) showed cracking in the bond coat region along the trailing edge (fig. 18(a)), which extends back into the ceramic flow path surface. Some ceramic cracking was also evident along the leading edge (fig. 17(b)), along with some surface microfracturing (fig. 17(a)). The right end of the shroud showed both vertical and bond-line cracking (fig. 18(b)).

(b) Backside.  
Figure 12. - Shroud segment after 1001 cycles.

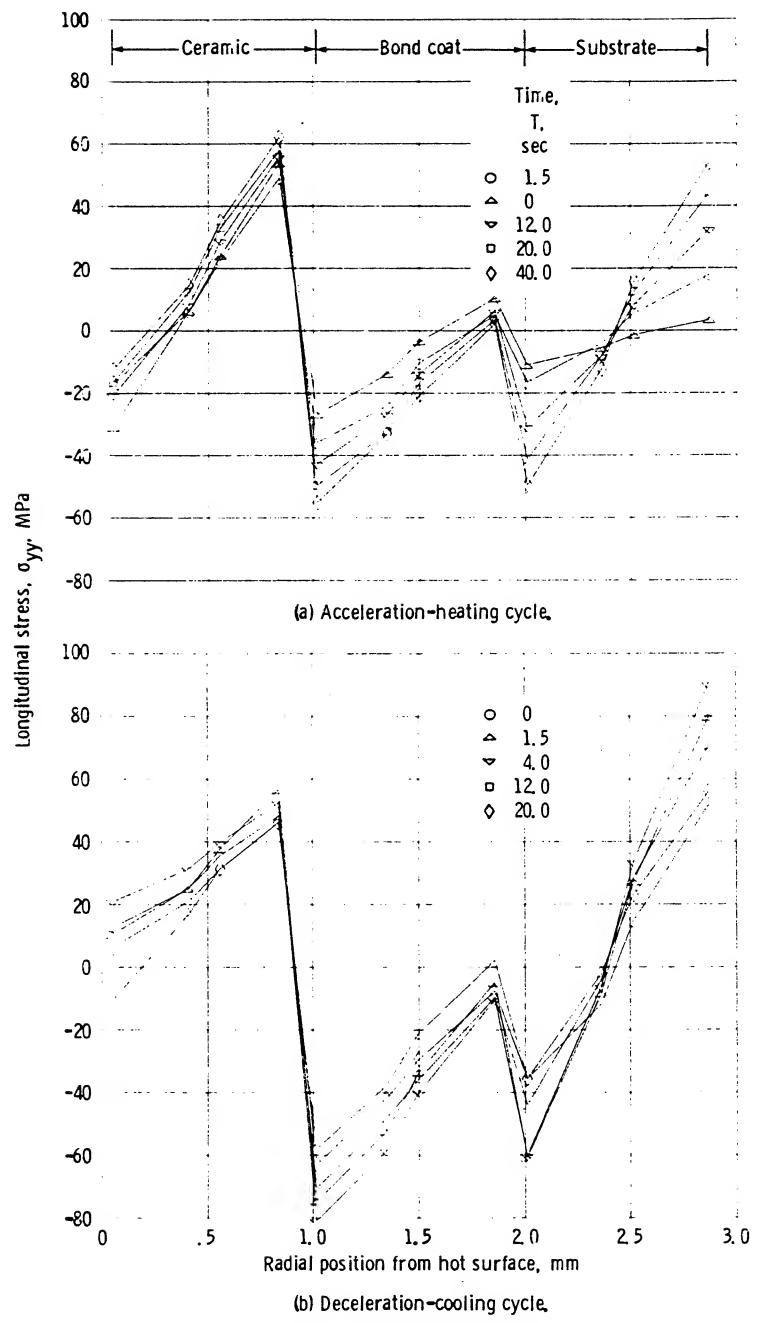
Figure 16. - Shroud longitudinal stress.

Using the thermal profiles generated by ADINAT, the radial, shear, circumferential, and longitudinal stresses within the shroud were computed. The longitudinal stresses are illustrated in figure 16 for the heatup and cooldown portions of the test cycle.

For this inelastic behavior case, radial and shear stresses are small, with the radial stresses negligibly small. The significant stresses for this case are the longitudinal and circumferential stresses, which are similar in magnitude. The longitudinal stresses are illustrated in figure 16 for the heatup and cooldown portions of the test. The longitudinal stresses are tensile at the surface during the cooldown portion of the cycle. These produce surface microcracking. Also, the stresses at the ceramic side of the bond coat and ceramic interface are always tensile, a condition leading to microcracking but not necessarily to material failure.

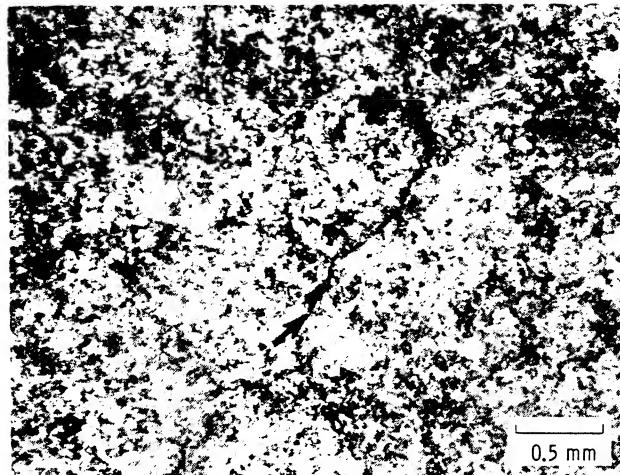
A metallurgical evaluation of a ceramic shroud segment is contained in appendix C. Highlights of the evaluation follow. A typical cross section through one of the ceramic shroud components shows that the ceramic coating thicknesses are not uniform. Figures 17 and 18 present micrographs of such a section. In figure 17(a) the section shows surface cracking. On an average the mud-flat cracks are about 1.5 mm (0.059 in) hexagonally spaced. Such large cracks have probably been preceded by microfracturing. Figure 18(b) indicates that the cracks tend to penetrate to the bond coat interface where cracking appears to either terminate or, in some instances, spread axially and perhaps circumferentially.

(a) Typical flow path crack.

(b) Ceramic crack leading edge.

Figure 17. - Micrographs of ceramic shroud section - flow path and leading edge.

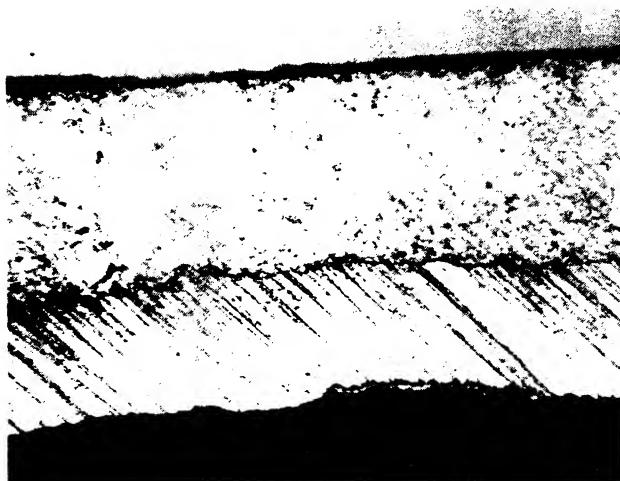
The degree of cracking around the outer perimeter was measured. Of the total perimeter length of 24.4 cm (9.6 in), 0.9 cm (3.6 in), or ~37.5 percent was cracked.

(a) Ceramic and frame crack trailing edge.

(b) Right end bond line and vertical crack.

Figure 18. - Micrographs of ceramic shroud section - trailing edge and right end.

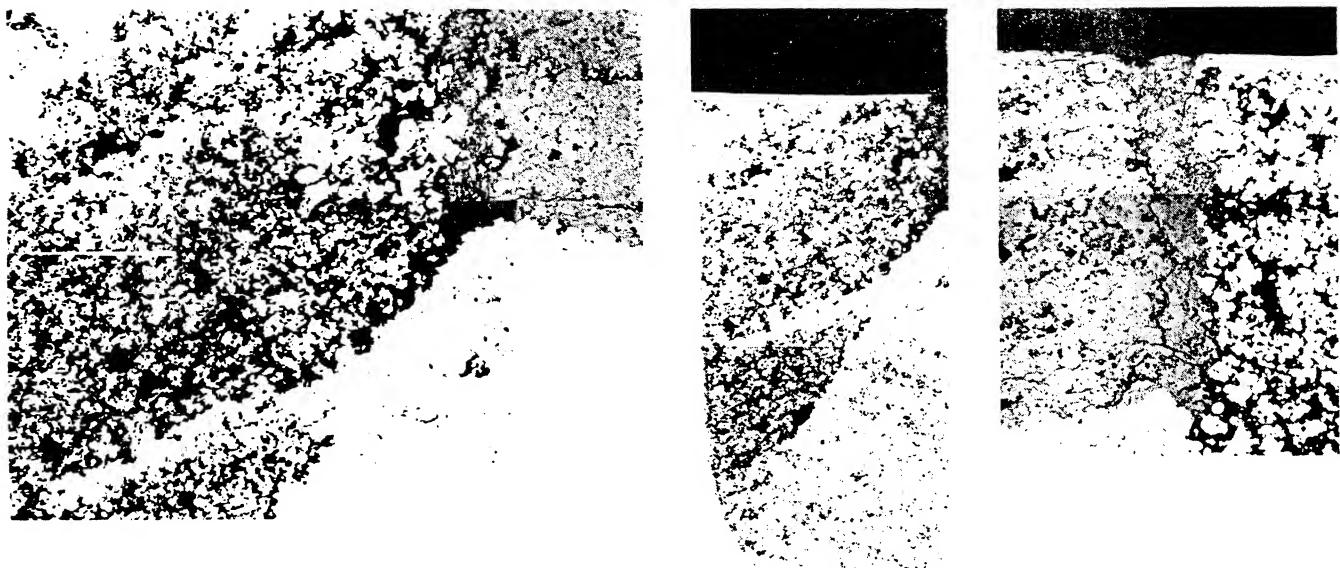
Shroud 6 was sectioned as shown in figure 19. Metallographic observation of the sectioned shroud indicates the bond coat thickness to be 1.14 to 1.27 mm (0.045 to 0.050 in) thick. The sprayed bond coat in the areas adjacent to the leading edge and trailing edge frame (fig. 20) were of low density, about 50 percent dense. Vertical cracking was also evident in the bond coat. Also noted was the presence of a "cooling" hole through the substrate into the bond coat. This hole does not extend into the ceramic top coat.

Figure 20. - Low density in bond coat adjacent to leading-edge and trailing edge frames.

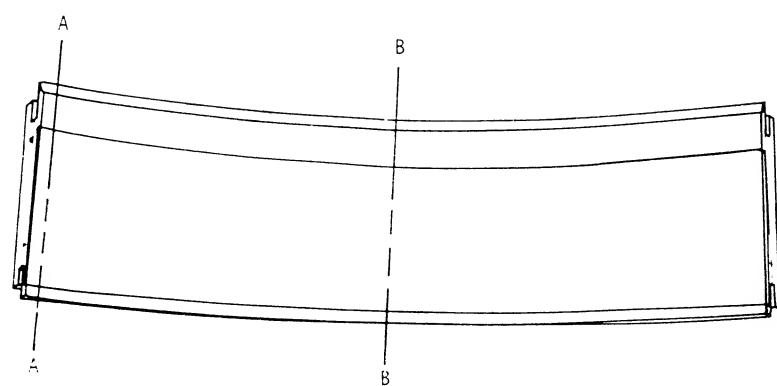
Figure 21. - Metallographic sectioning locations.

Pretest and posttest microstructures of the plasma sprayed coatings (yttria-stabilized zirconia and NiCoCrAlX) on the engine shroud segments were examined. (Section locations are given in fig. 21.)

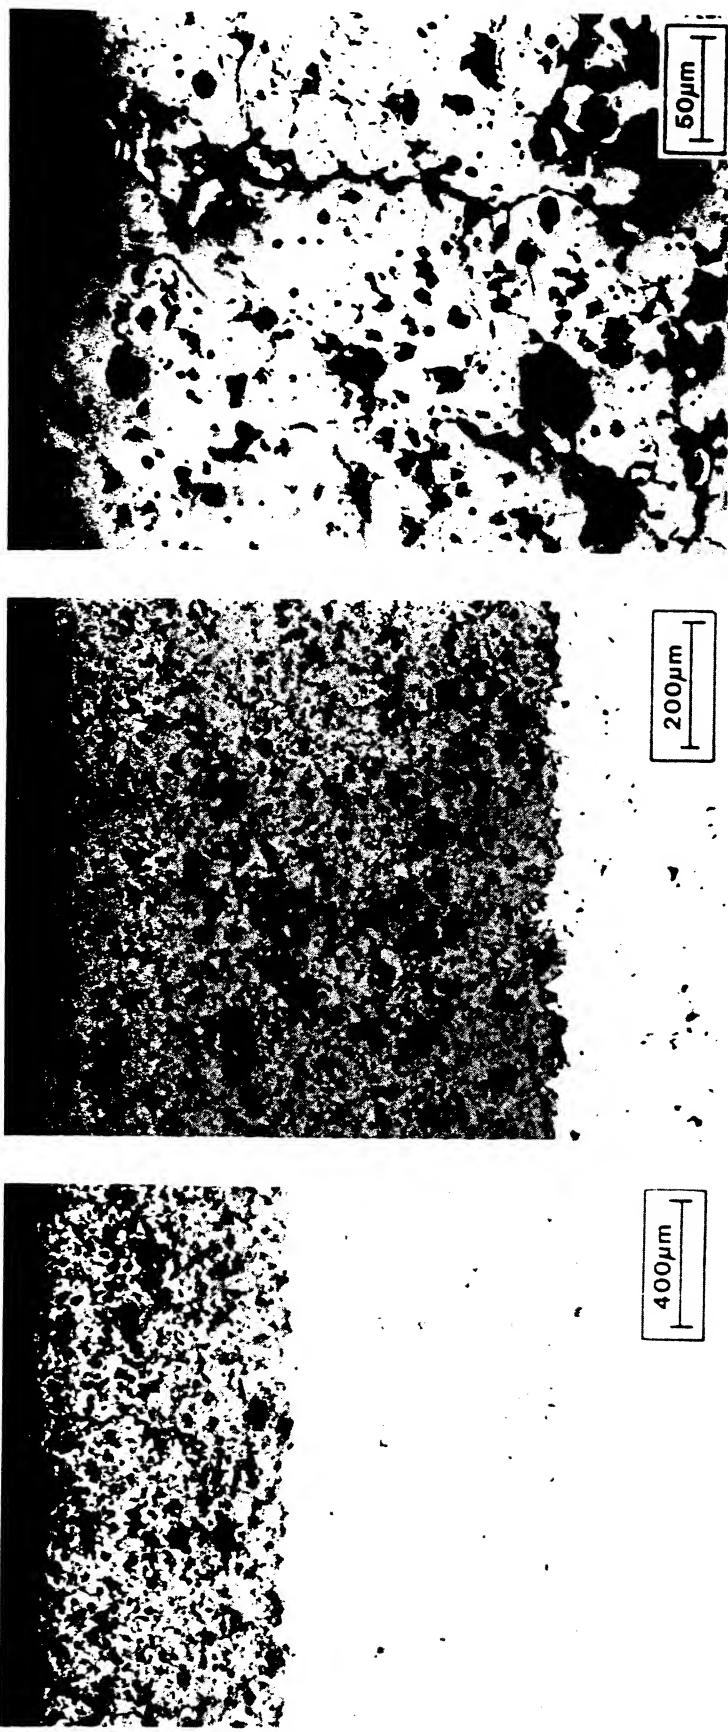
The pretest micrograph (fig. 22(a)) was examined on a quality control specimen that was not run in the engine. The micrograph reveals some vertical cracking which provides strain relief.

(a) Pretest microstructure; cross section B-B.  
Figure 22. - Plasma-sprayed shroud seal. (See fig. 21 for cross-section positions.)

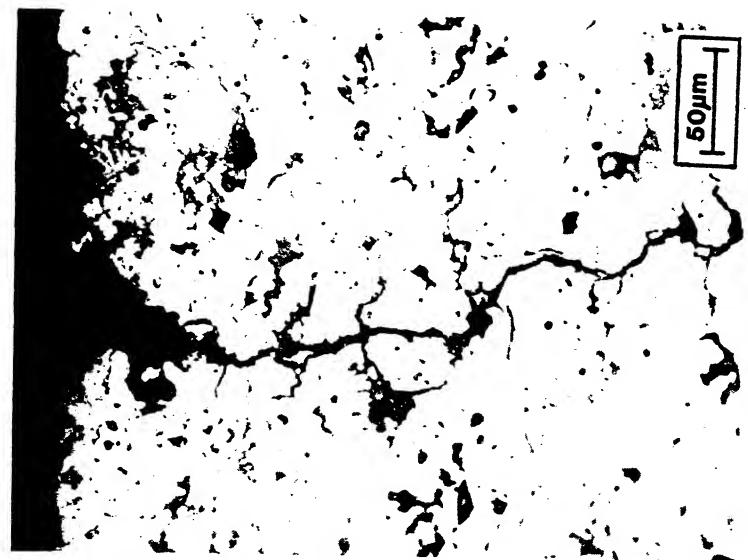
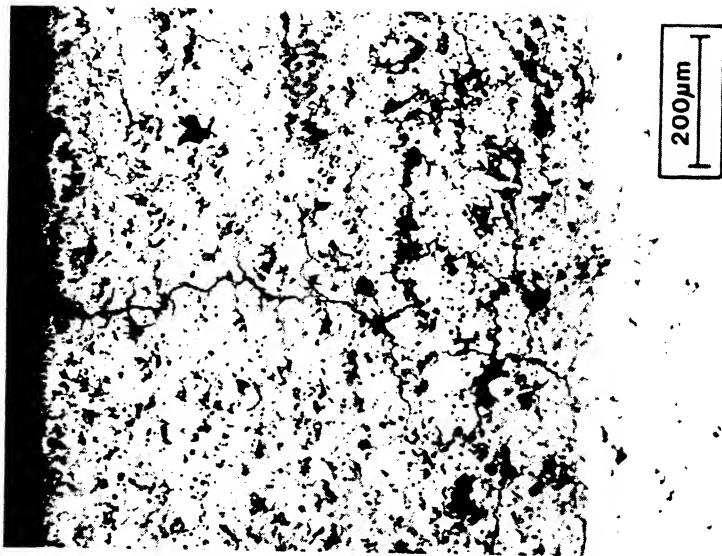
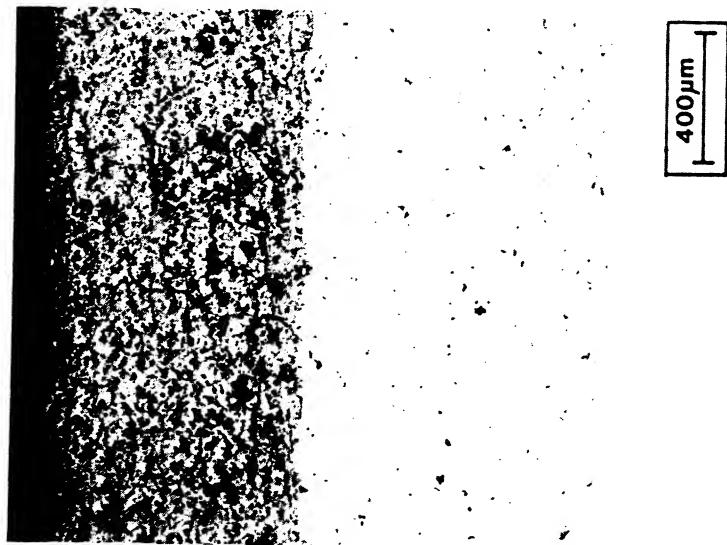
Examination of posttest ceramic coating microstructure (figs. 22(b) and (c)) revealed extensive segmentation, commonly called mud-flat cracking, and some local areas of lateral cracking and large porosity. Apparently, densification of the ceramic occurred. Caution must be exercised here, however, as observed microstructures are very dependent on metallographic polishing methods. The metallic bond layer exhibited considerable porosity, predominately due to pullout during metallographic polishing which was optimized to reveal the ceramic microstructure. The extensive porosity noted next to the leading and trailing edges was due to the geometry of the part not having been optimized for plasma spray coating. No evidence of any significant oxidation or  $\beta$ -phase (NiAl) depletion on the NiCoCrAlX bond layer was noted. Variations in the thickness of the metallic and ceramic layers found in sections AA and BB are due to impression of the process.

(b) Posttest microstructure; cross section A-A.

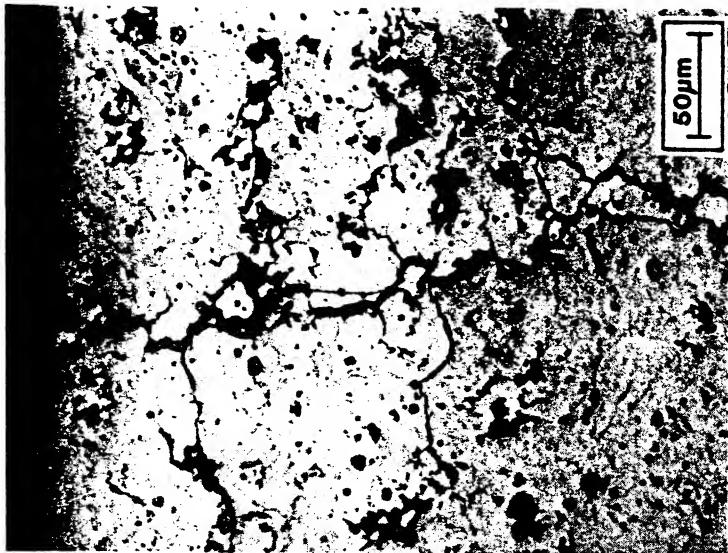
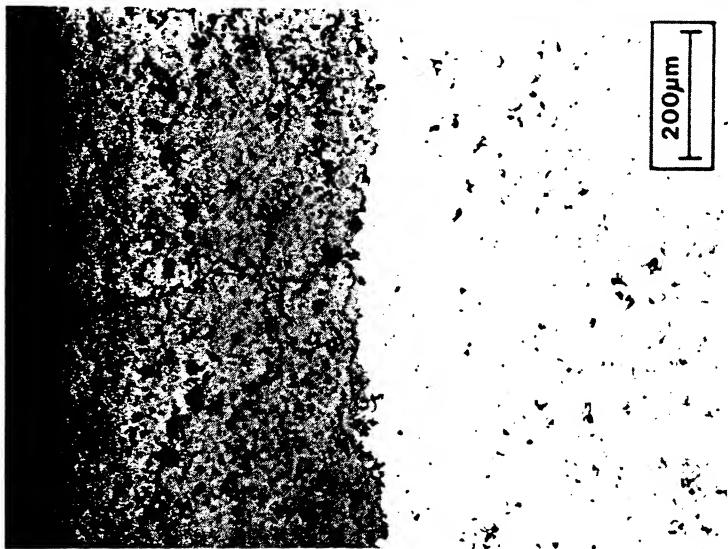
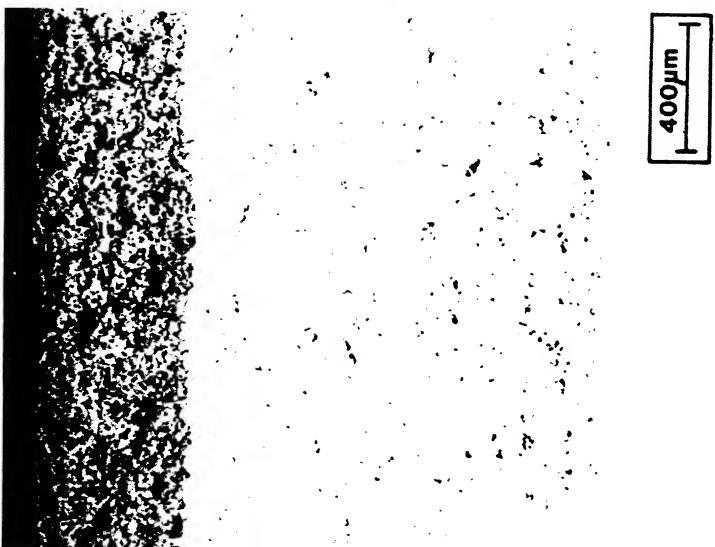
(c) Posttest microstructure; cross section B-B.
